Design Analysis and Space Layout in the Radiology Installation of Buleleng District Hospital

Ayu Evelina Otu

Jurnal Ilmiah Manajemen
Kesatuan
Vol. 12, No. 5, 2024
pp. 1483-1490
STIE Kesatuan
ISSN 2337 – 7860

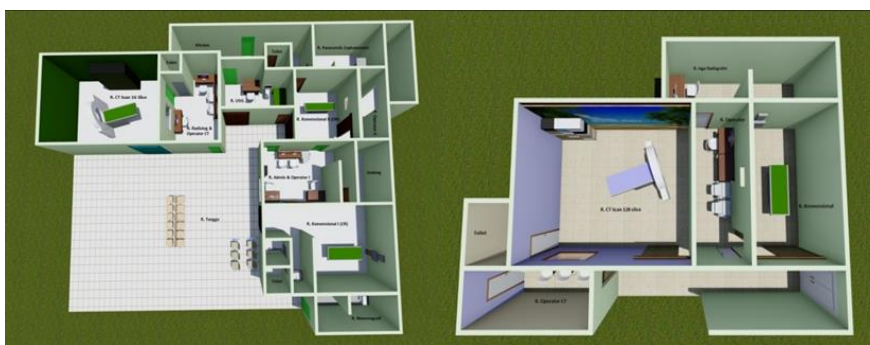
The Radiology Installation of Buleleng District Hospital is divided into 2, namely the central unit and the Emergency Installation. For central access, it is close to the polyclinic, registration counter, and lab. For radiology, the Emergency Installation is certainly close to the emergency unit, pharmacy and lab too. The layout is very easy to access. In general, access to radiology is quite easy even though there are several inpatient rooms that are located or further from other rooms because Buleleng District Hospital is quite large so that there are several rooms that are quite far away but can still be easily accessed to the radiology installation.

Figure 1. Central Radiology Floor Plan & Emergency Room Radiology Floor Plan

If in terms of design, the first is in the Emergency Installation section because the design is quite winding and the corridor is narrow, usually Emergency Installation patients who come queue with a bed so that access in and out is slightly hampered. While in the central, in terms of design, the panoramic room is located at the back and does not have its own entrance access so that to enter the panoramic room you must go through the conventional room II (Doctor's room) first, so when there are panoramic patients and patients who are being worked on in the Doctor's room (contrast

The radiology installation at Buleleng District Hospital is divided into two parts, namely Central Radiology and Emergency Installation Radiology. Central Radiology is located in the northern part of the hospital, close to the laboratory and easily accessible from the outpatient clinic and inpatient room. Meanwhile, Emergency Installation Radiology is located in the western part of the hospital, close to the emergency unit and operating room. The Radiology Installation Building at Buleleng District Hospital meets the provisions of Minister of Health Regulation No. 24 of 2020 and BAPATEN Regulation No. 4 of 2020 by having a patient waiting room, administration room, examination room, operator room, radiologist room, and standard equipment. The spatial arrangement has been designed to facilitate patient access from various units, as well as minimize the risk of radiation exposure for visitors and officers with a clear separation between the public area and the radiation officer's work area.
